City of Detroit
Department of Recreation Performance Audit
Exhibit 1 – Belle Isle

Scott Fountain

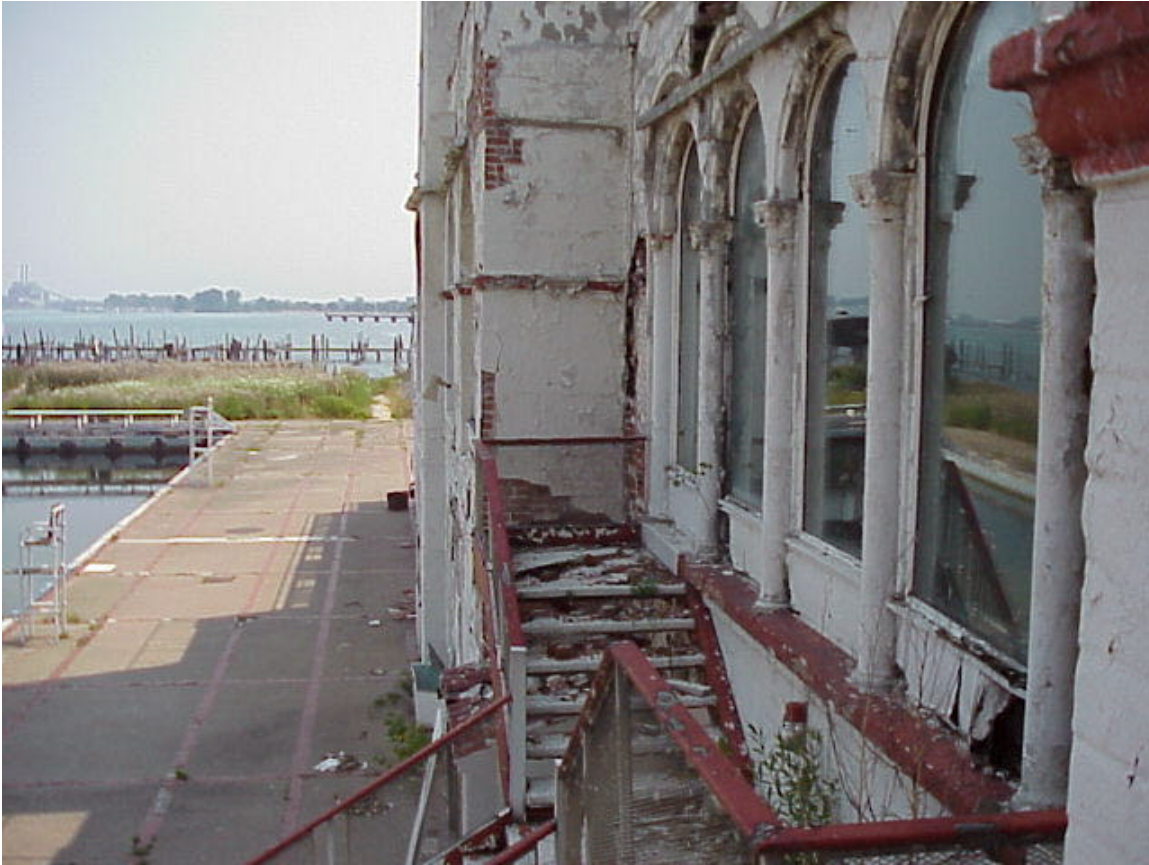
The exterior of the boat club had peeling paint, crumbling walls, a broken window and unsafe stairs.

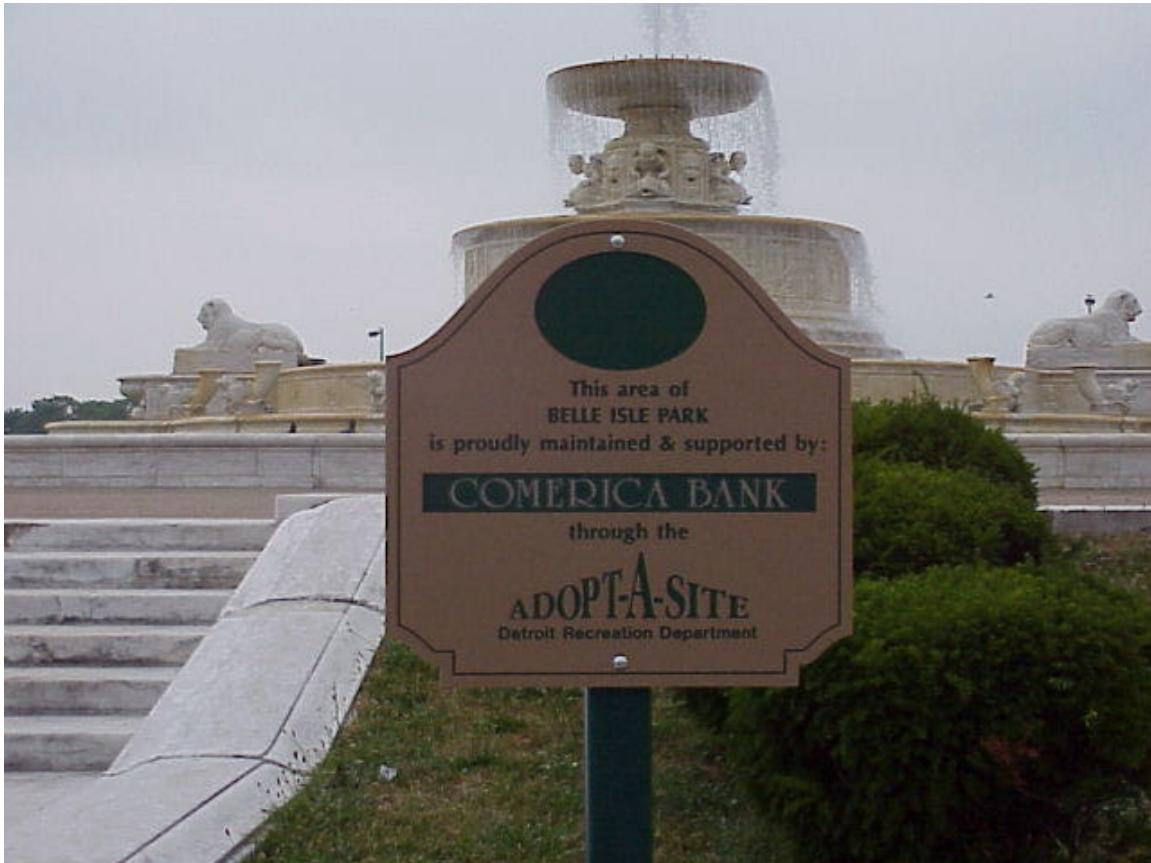
Overall Evaluation – Good Condition

- Overall structure appeared to be sound.
- Grounds and shrubs around the fountain were neatly kept.
- There were some water stains on the monument.

The fountain was in working condition with neatly trimmed shrubs and free of litter. Some water stains on fountain were shown.

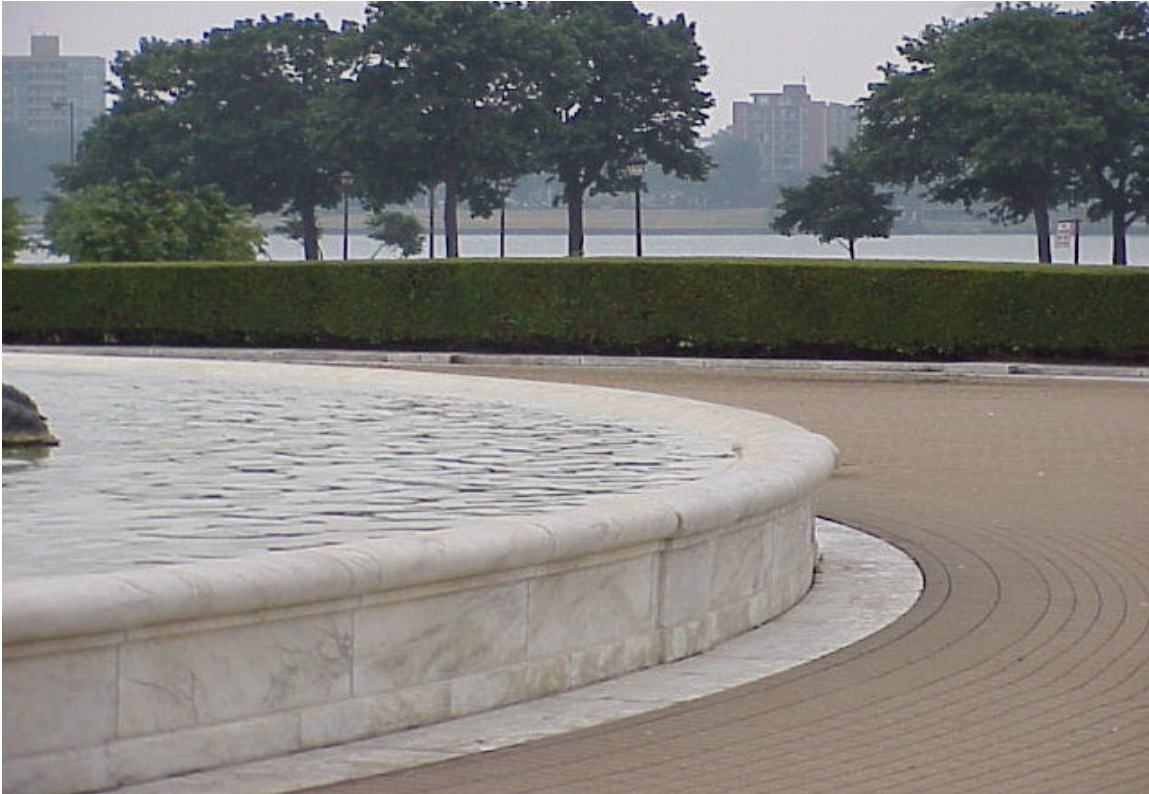
The fountain appeared to have a sound structure and was well maintained.
